POLICY BRIEF OUTLINE:

Optimization of rice production in the Nanan rice perimeter (Yamoussoukro-Côte d'Ivoire)

COopérative des PROducteurs de RIZ (COPRORIZ)

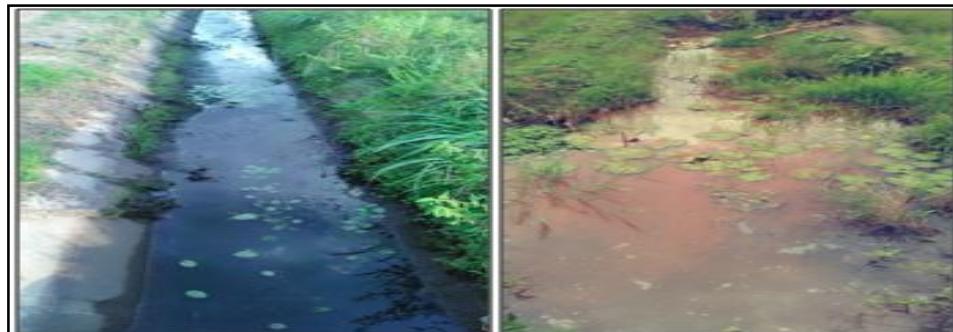
Figure 3: Photographs illustrating silted and grassed canals

With regard to hydraulic works, the fact is that the hydraulic infrastructures of the Nanan rice scheme are in poor condition for the most part. At the start of the project, the primary canal was suffering from a serious problem of silting and grassing along its entire length and in its surroundings (Figure 3).

As far as maintenance is concerned, COPRORIZ will have to reinforce the authority of the Management Committee of the developments in charge of the hydraulic network in order to avoid all kinds of drifts. The responsibility for the maintenance of the hydraulic network must be perfectly defined. It therefore appears, in view of these observations, that the main factors acting on irrigation efficiency and water productivity in the Nanan irrigated rice perimeter are of an organisational and technical nature. COPRORIZ will have to make available to the head of the Development Management Committee the necessary human, financial and material resources to enable him to deal with any kind of network dysfunction.

Furthermore, it is essential that rice farmers take care of the irrigation network and organize themselves for its maintenance and in case of failure. They must ensure preventive maintenance (cleaning, plugging breaches) and periodic maintenance (cleaning canals and drains, repairing embankments) of the perimeter.

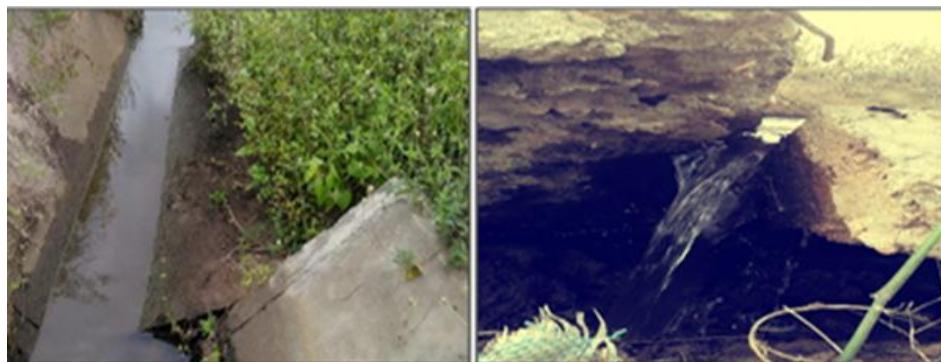
Figure 4 : Photographs illustrating the degraded main channel (breaks and cracks)

Secondary drains are virtually non-existent along the entire perimeter. Each farmer has to take care of the maintenance of the section of the primary canal that serves his plot himself. However, this is not done on the entire perimeter. Furthermore, it can be seen that the main canal is cracked and destroyed in some places along its length (Figure 4), especially at the joints.

These breaches allow a considerable amount of water to leak out. In addition, almost all the mobile valves of the irrigation intakes serving the plots are no longer properly functional.

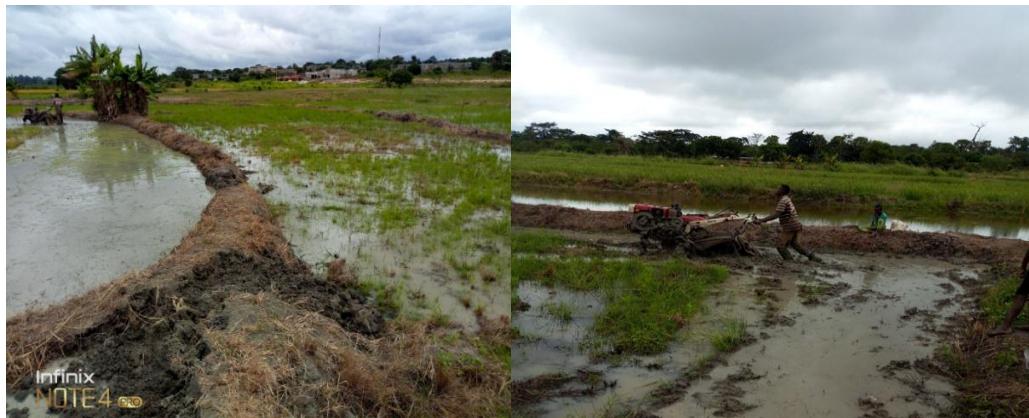
Figure 7: Ploughing work with a tiller

Always with the aim of helping rice farmers to improve production, because it has to be said that there is a lack of motorized equipment for ploughing, we have therefore rented a motorized cultivator to help them. Thus, two (2) experimental plots were chosen. For this purpose, ploughing and soil preparation were carried out with a tiller and a tractor (Figure 7).

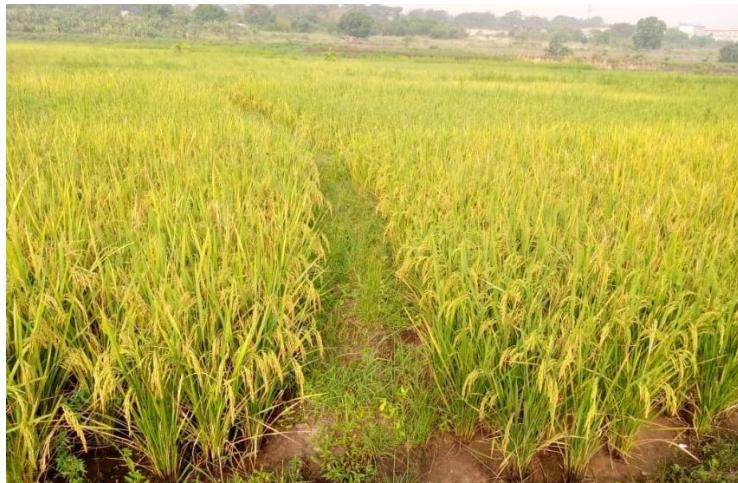
Figure 8: Experimental plots at maturity

The average yield on the experimental perimeter was 4.5 tons/hectare before the works. Accompaniment on these plots respecting all the conditions of the cultivation techniques with the support of the UAV was able to give a yield close to 7.3 tons/hectare (Figure 8).

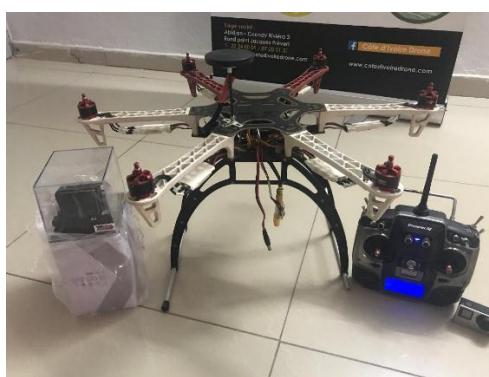
Figure 9 : Drone for crop monitoring

The first approach concerns the use of a UAV. Indeed, it is an innovative device that optimizes the yield of agricultural land thanks to its multiple functionalities. The images taken by the georeferenced sensors give precise indicators that will be used to improve productivity. Thus, thanks to its multi-spectral sensors, the UAV makes it possible to: carry out management plans; diagnose areas of disease, the least fertile or least hydrated areas and provide appropriate treatments; manage water resources and save inputs. We have therefore acquired a drone (Figure 9) that has been tested on a single cropping cycle with satisfactory results, but which will be deployed over the entire rice perimeter in the next cropping cycles by starting ploughing and sowing at the same time.

Studies have also shown that it is possible to improve yields per hectare with the help of UAVs and the respect of cultivation instructions. However, monitoring could only be carried out during a single cropping cycle. It would be desirable to confirm this technology through other cropping cycles. The importance of this technology deserves that this study be continued for the well-being of rice farmers. However, the UAV's capabilities will only be effective if farmers are able to start the agricultural seasons at the same time. It is an innovative tool that will make it possible to considerably increase yields.

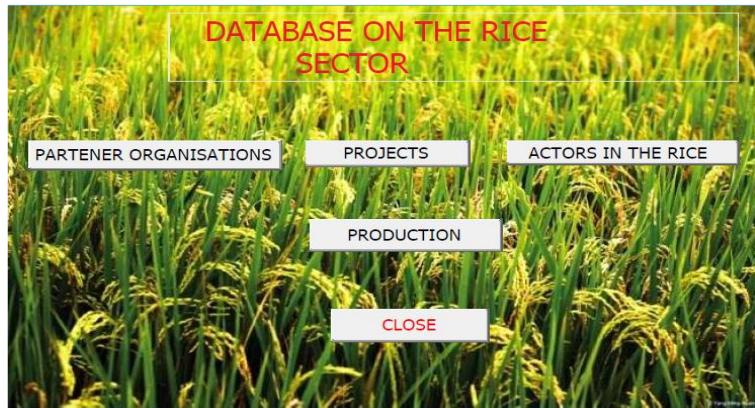
Figure 10 : Rice perimeter information system

The second approach is the development of a database and platform. Based on the results obtained, we began by developing a database to capitalize all the data collected on the perimeter in order to facilitate future actions to be carried out on the perimeter (Figure 10). This information system should eventually lead to a platform where producers will have access to updated information on their plots, photos, videos, reports and figures on their farms. It will also be an opportunity to have access to the external market for added value of their activities.
